THOMPSON HOME INSPECTION, INC.

## SB-721 INSPECTION

01/08/2026

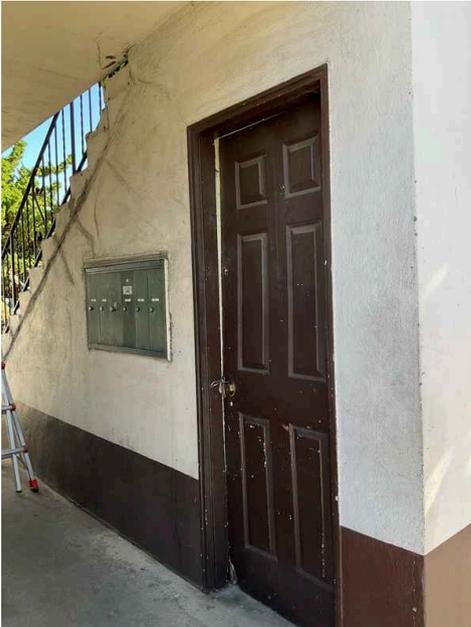
### **LOCKED DOOR**

Locked access door underneath stairway preventing the inspection of the underside of the element.

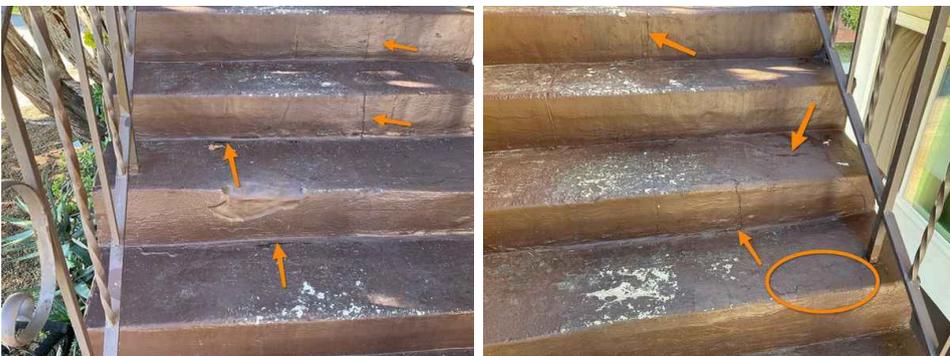
### 3.3.1 Associated Waterproof Elements

#### CRACKS IN MEMBRANE

Non-Emergency

Visible cracks in the waterproof membrane on decks, roofs, or balconies allow water penetration, risking damage to underlying structures. Remove the affected membrane sections and replace them with a new, high-quality waterproofing system. Ensure all edges and seams are properly sealed.

Recommendation

Contact a qualified professional.

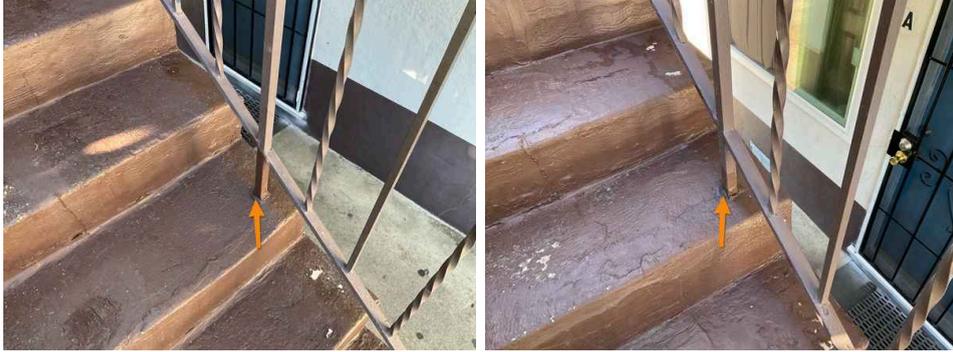
### 3.3.2 Associated Waterproof Elements

#### OPENING ON MEMBRANE

Non-Emergency

Separation between guardrail post and membrane that may allow water intrusion into the wooden interior.  
Recommendation patching with sealant to plug any open exposures.

Recommendation

Contact a qualified professional.

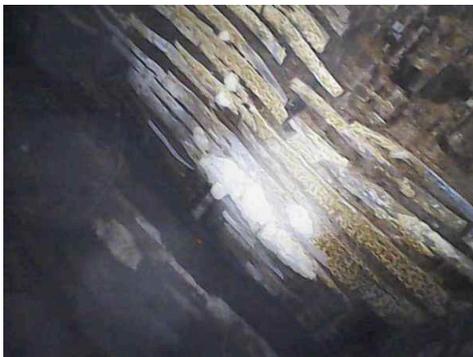
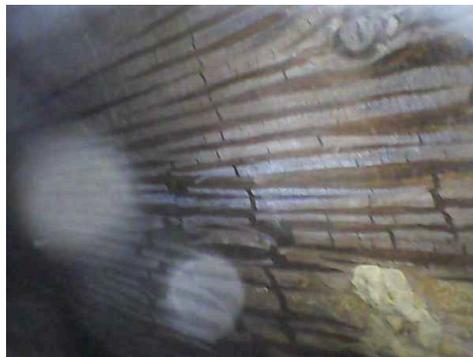
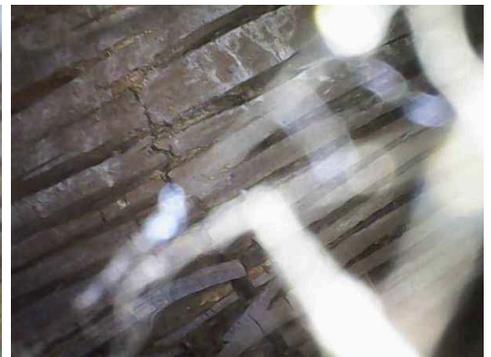
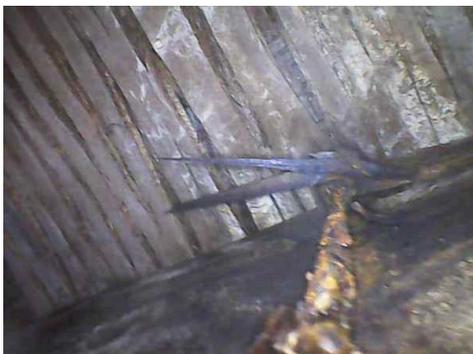
### 4.1.1 General Elements

Non-Emergency

#### **WATER DAMAGE**

Swelling, discoloration, and/or softness of wood indicates likely moisture damage. Soft or flaking wall surfaces and/or damaged wood members suggest water intrusion. Remove affected materials for a thorough inspection. Repair or replace damaged components and ensure proper waterproofing measures are in place

Hole 4

Recommendation

Contact a qualified professional.

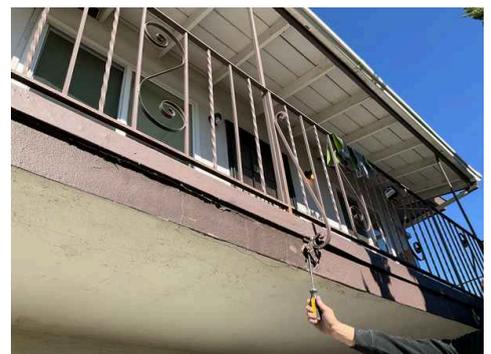
### 4.1.2 General Elements

Non-Emergency

#### **LOOSE GUARDRAIL**

Guardrails on the element are loose, posing a safety risk. Securely fasten loose guardrails to the structure. Ensure all connections meet current safety standards and building codes.

Recommendation

Contact a qualified professional.

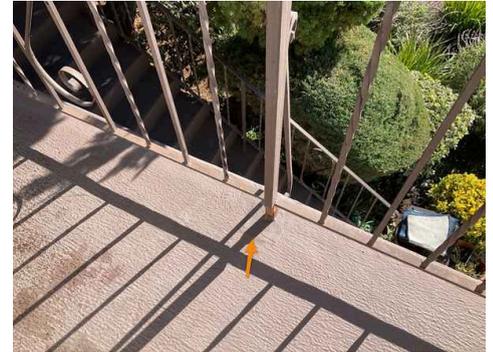
#### 4.3.1 Associated Waterproof Elements

### CRACKS IN MEMBRANE

Non-Emergency

Visible cracks in the waterproof membrane on decks, roofs, or balconies allow water penetration, risking damage to underlying structures. Remove the affected membrane sections and replace them with a new, high-quality waterproofing system. Ensure all edges and seams are properly sealed.

Recommendation

Contact a qualified professional.

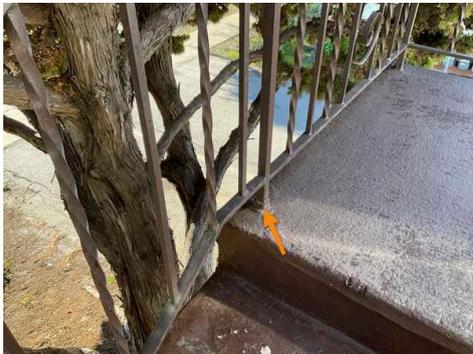
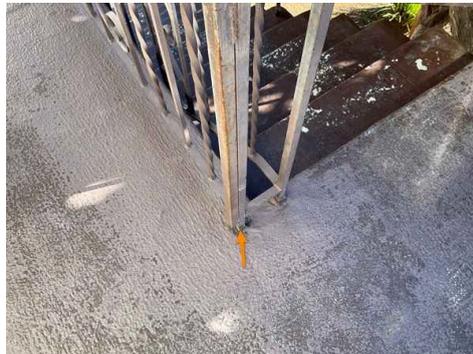
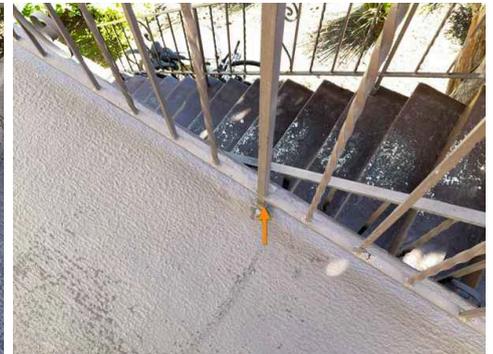
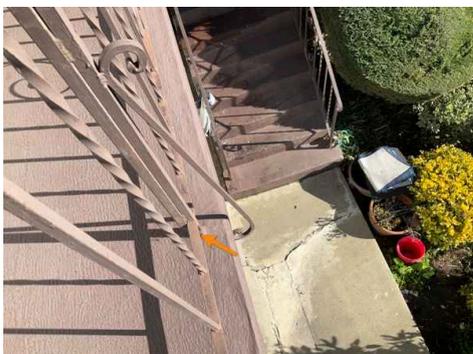
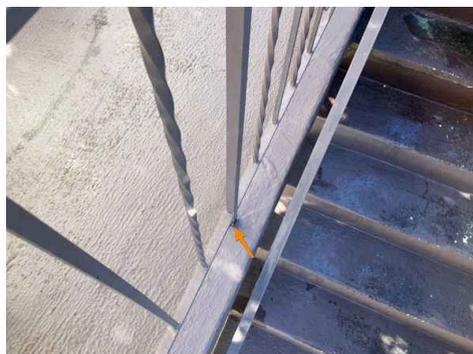
#### 4.3.2 Associated Waterproof Elements

### OPENING ON MEMBRANE

Non-Emergency

Separation between guardrail post and membrane that may allow water intrusion into the wooden interior. Recommendation patching with sealant to plug any open exposures.

Recommendation

Contact a qualified professional.

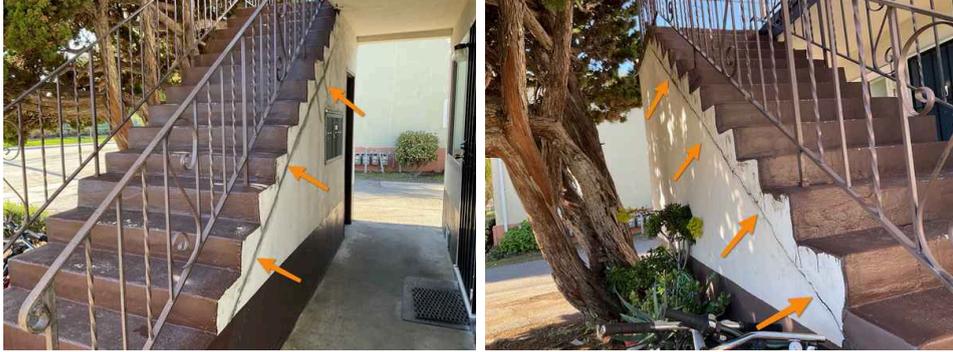
#### 4.3.3 Associated Waterproof Elements

### CRACKS IN STUCCO

Non-Emergency

Cracks in stucco may allow rainwater to enter and caused damage to the wood framing members. Recommend these cracks be properly sealed by a qualified contractor.

Recommendation

Contact a qualified professional.
