THOMPSON HOME INSPECTION, INC.

## SB-721 INSPECTION

01/08/2026

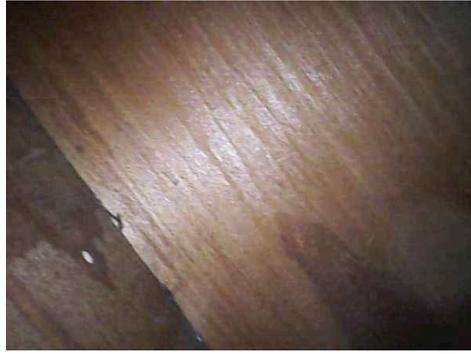
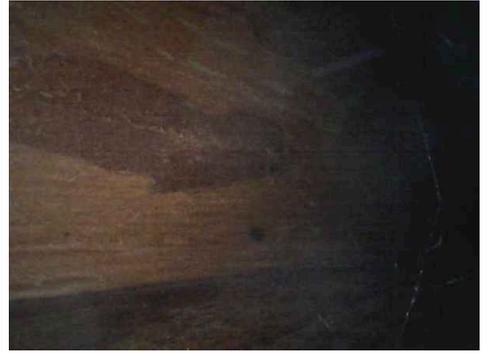
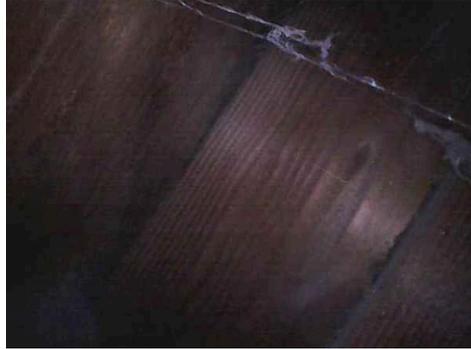
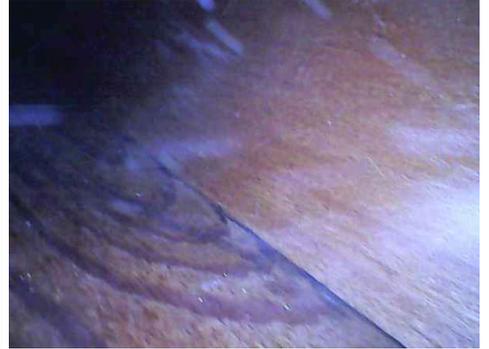
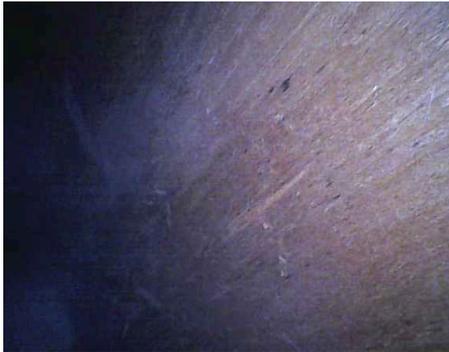
## General Elements: Boroscope Samples

This section contains boroscope images of the EEE, providing an examination of internal conditions essential for detecting potential issues not otherwise visible.
